# Journal of Geology, Geography and Geoecology

K.I. Derevska, V.V. Manyuk, K.V. Rudenko, V.V. Manyuk

## Comprehensive assessment of the environmental impact of coastal development in the Dnipro River, exemplified by the city of Dnipro

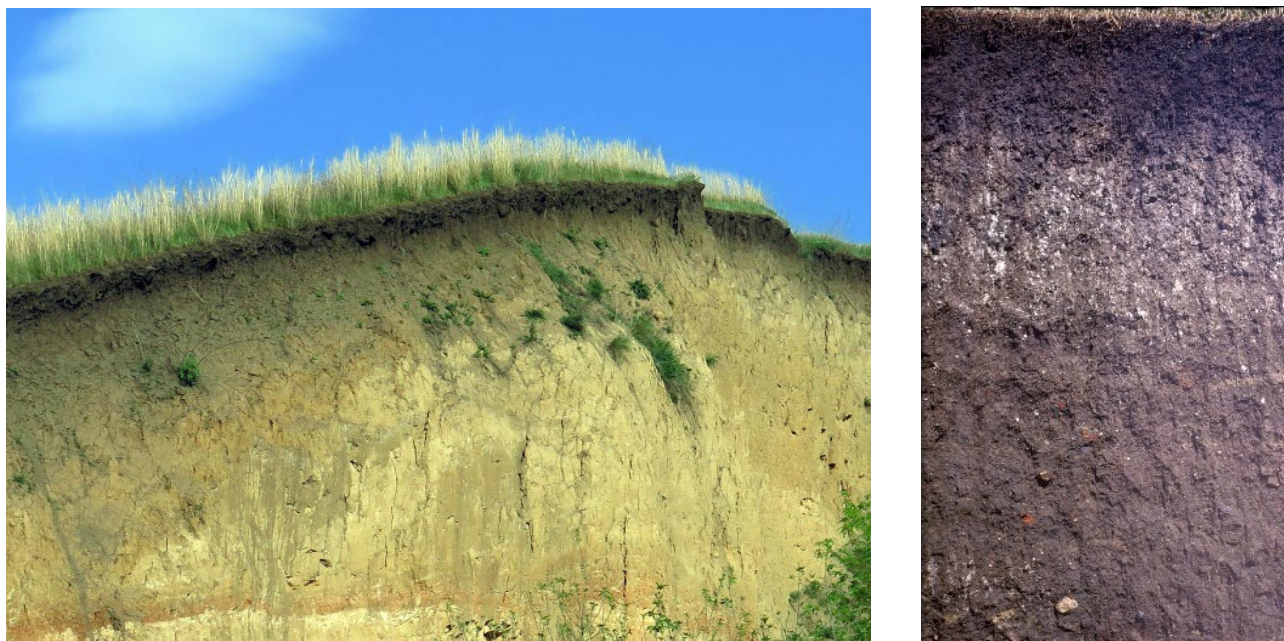
**Fig. 4.** Ordinary medium-humus chernozem on loess-like loams of the Black Sea climatic type (Sazhavka basin) and meadow-chnozem soil of the floodplain (right, [https://uk.wikipedia.org/wiki/Лучно-чорноземні\\_грунти](https://uk.wikipedia.org/wiki/Лучно-чорноземні_грунти))

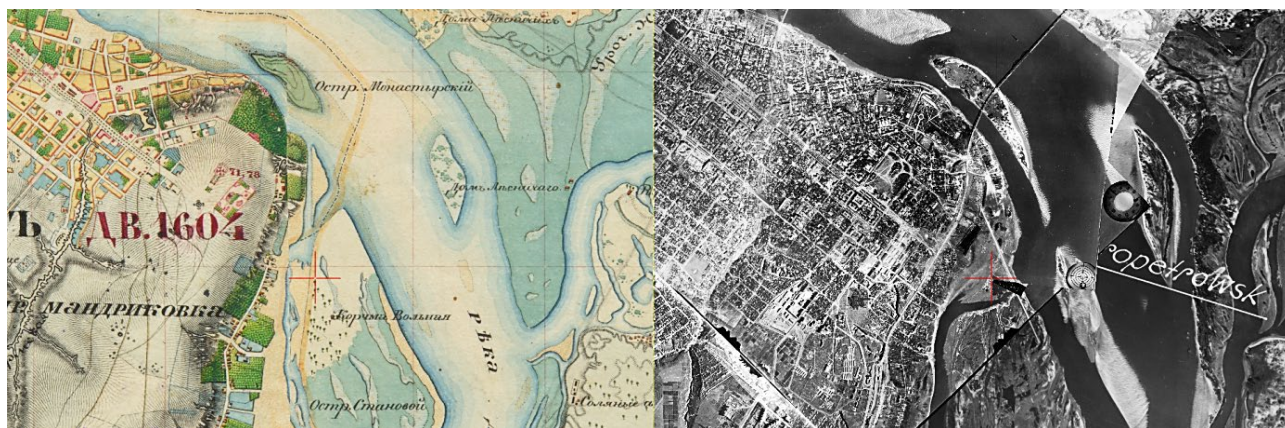
**Fig. 6.** The upper part of Stanovyi Island on the topographic map of 1853 (left), and on the aerial photograph of 1941 (Collection of detailed maps..., 2026)

The studied area was historically (until 1932) the upper part ("head") of the large river island of Stanovyi (also known as Vorontsovsk or Kinsk). The island was separated from the main channel of the Dnipro by the old riverbank (Fig. 6), which ran approximately along the current Naberezhna Peremohy Street (Collection of detailed maps..., 2026). With the completion of the construction of the Dnipro Hydroelectric Power Plant dam, the island was almost completely flooded by the waters of the Zaporizhzhia reservoir. In 1941, after the demolition of the Dnipro Hydroelectric Power Plant dam, the water level in the reservoir dropped significantly (but did not reach the original levels of the Dnipro riverbed before the flooding). The flooded island resurfaced several times over the years, but was finally submerged by 1947. In the shallow waters that formed on the site of the flooded island, large-scale sand dredging began in the early 1970s (to support the construction of the embankment and new residential areas). As a result, a secondary dredged area was formed, an artificial peninsula with a total area of about 30 hectares. In the southwestern part of the peninsula, a cape-like protrusion measuring up to 5 hectares was formed, on which a boat station with a network of internal canals and berths was later built in the second half of the 1970s. In the 1990s, the base gradually fell into disrepair, and the canals were partially silted up and partially filled in by new land users. The area is at an altitude of 51.5–58 m above sea level. An old axial road passes through the peninsula, built on an alluvial dam in the late 1930s.
